# MACHINING AND ENGINEERING SERVICES

**Has the bearing you need been discontinued?**

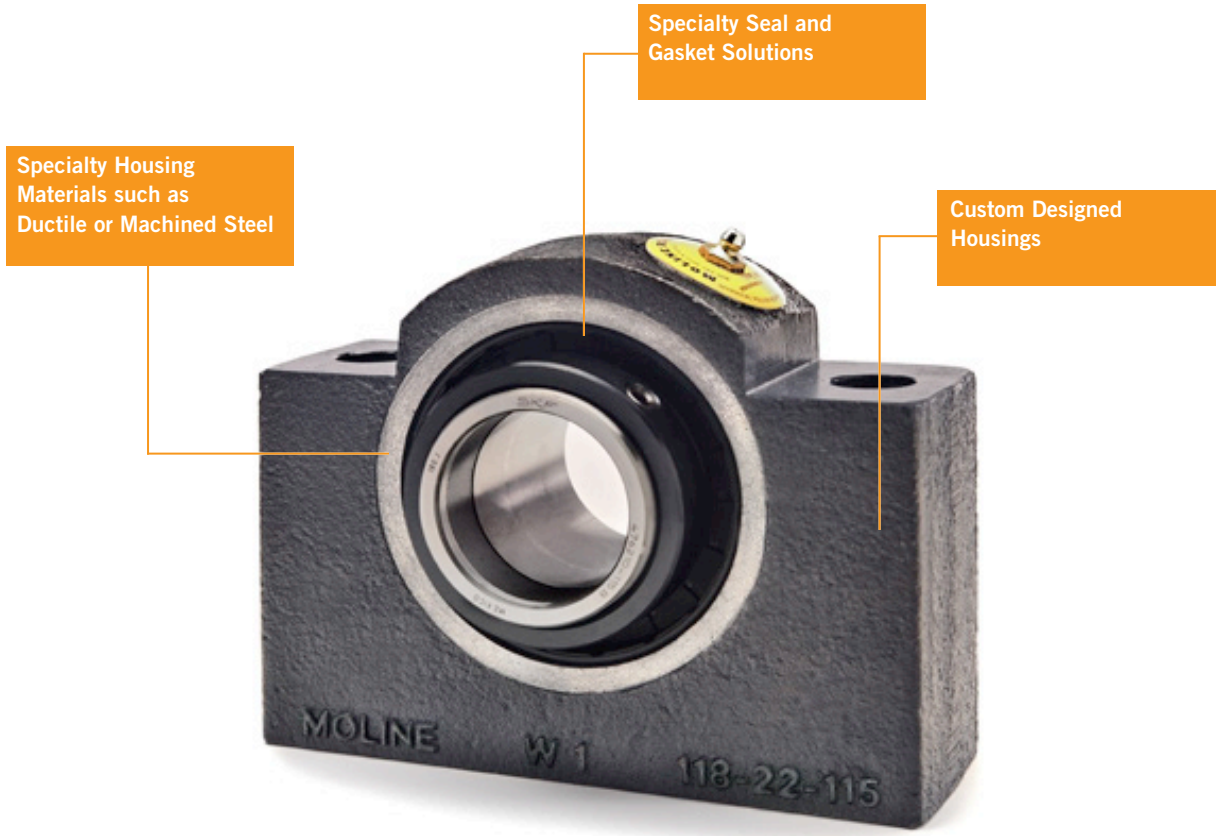
Product	Customer Problem	Moline Solution/Benefit
Grab Roller Bearing	The original cast iron design of this agricultural bearing was breaking. An attempt to use a weldment also failed.	Moline provided this housing in ductile iron and increased the thickness of the bolt pad to allow a larger bolt thus decreasing the chance of housing failure.
